Canadian Coast Guard Ship CCGS Bartlett

Asbestos Risk Assessment

CCGS Bartlett Asbestos Inventory 2017

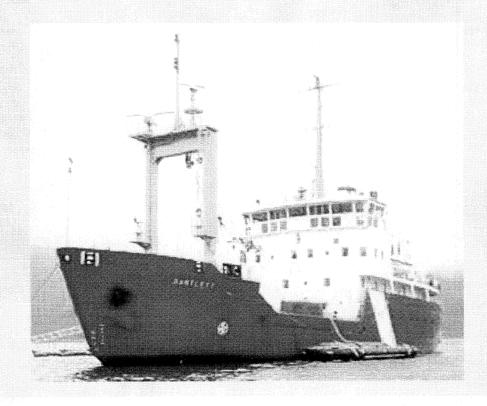
Maintain asbestos containing lagging in good condition.
